# Corrosion degradation of spacers – examination of changes in bone cement coating

*European Journal  
of Medical Technologies*  
2017; 3(16): 24-32

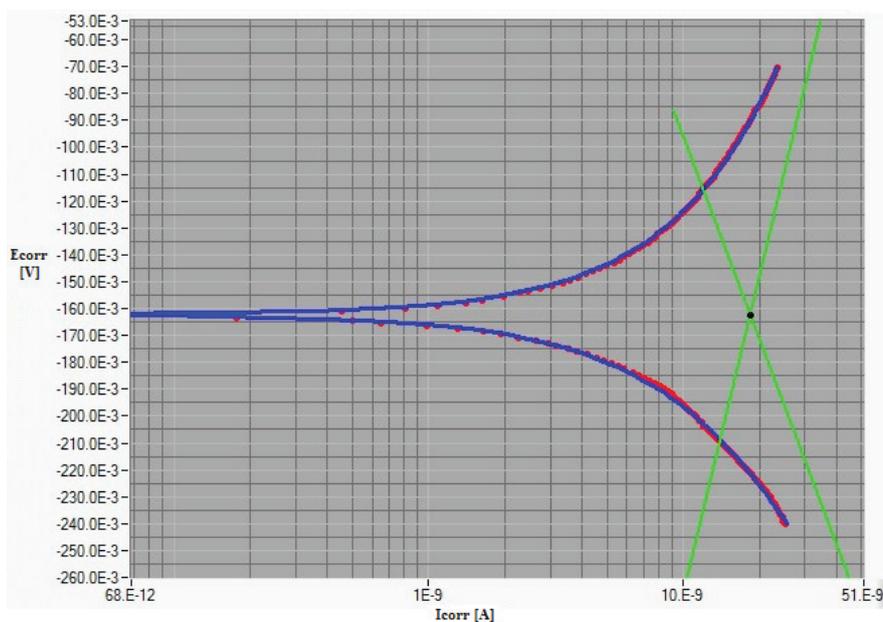
**Fig. 3.**

Sample Tafel extrapolation chart for titanium specimen with bone cement coating (Ringer's solution, high viscosity bone cement)

Three electrodes were used in the study: counter electrode (standard platinum electrode), reference electrode (Ag/AgCl saturated with potassium chloride KCl) and electrode discharged from the test sample. In the studies corrosion potential ( $E_{corr}$ ) and corrosion current density ( $i_{corr}$ ) were specified from the polarization curves by using the Tafel extrapolation method (Fig. 2). Example application of this method is shown on Fig. 3.

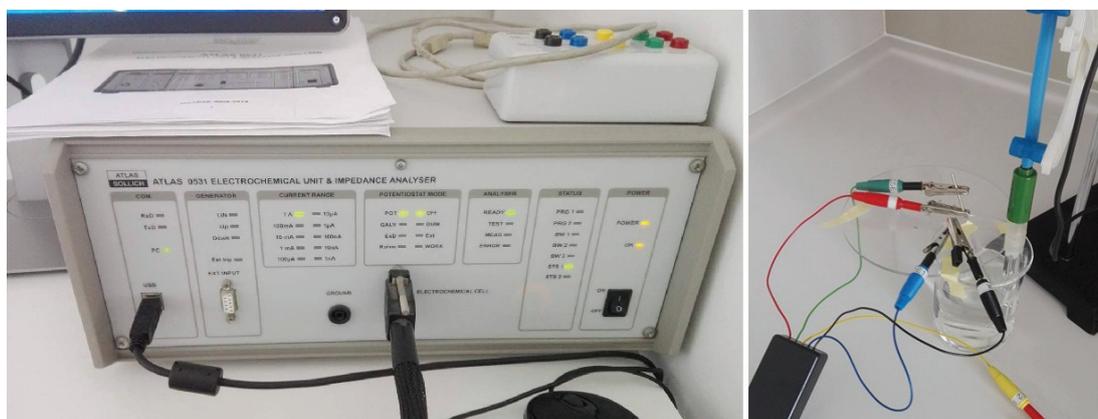
**Fig. 4.**

Corrosion test stand

The studies were conducted on potentiostat/galvanostat Atlas 0531 (Atlas Solich). The parameters were as follows: a potential change rate – 1 mV/s, a scan range 600-2000 mV. The test stand is shown in Fig. 4.

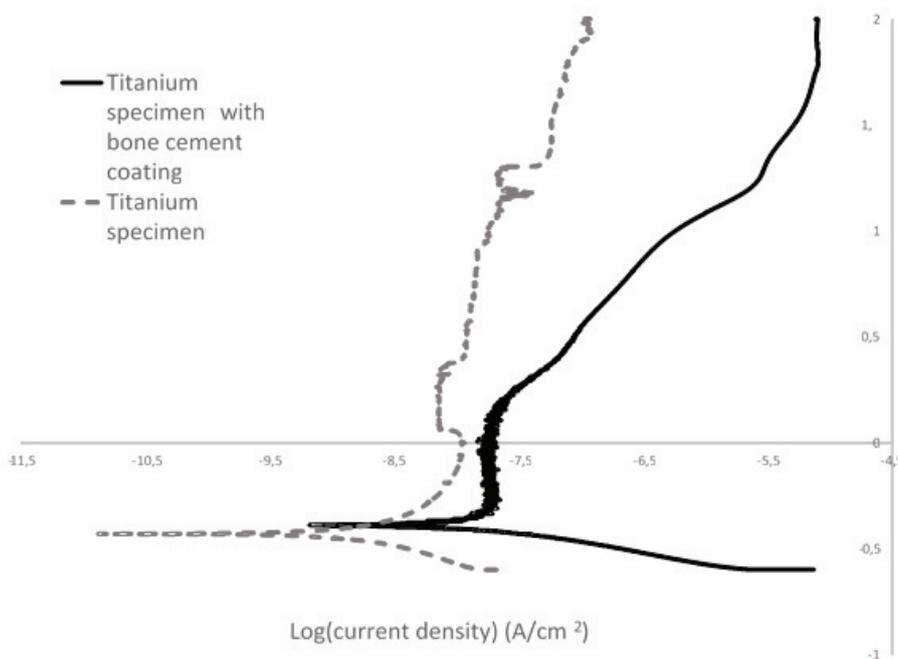
**Fig. 5.**

Sample potentiodynamic polarization curves of tested specimens in Ringer solution (spacer based on high viscosity bone cement)

titanium specimen and one titanium specimen with bone cement coating is shown on Fig. 5.

It can be stated that the high viscosity bone cement coating reduces the corrosion current density by an average of 28.87% in Ringer's solution and 24.96% in Artificial Saliva solution and increase corrosion potential by 27.96% in Ringer's solution and 2.37% in Artificial Saliva solution. Fig. 4 shows the potentiodynamic polarization curves shift to the right, which means improved corrosion resistance.

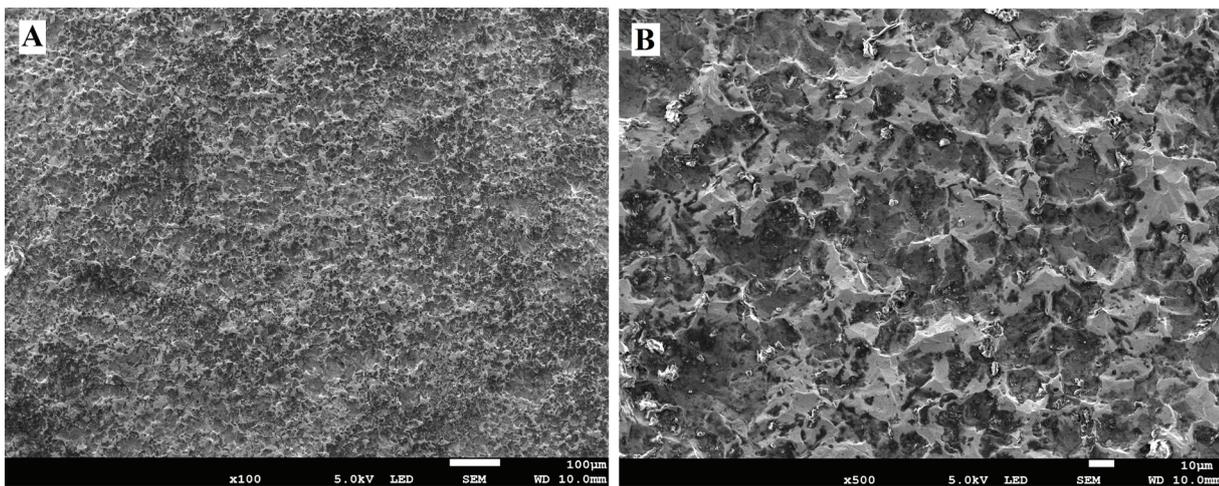
**Fig. 6.**  
Topography of the surface of titanium before the corrosion test (A-100x, B-500x)

Corrosion studies, however, affect to the structure of investigated materials. After the tests specimens were investigated using SEM microscopy. The topography of the titanium surface prior to the test is shown in Fig. 6 and of the bone cement surface in Fig 7. In contrast, Fig. 8, Fig. 9 and Fig. 10 show the topography after a corrosion test in SBF solution.

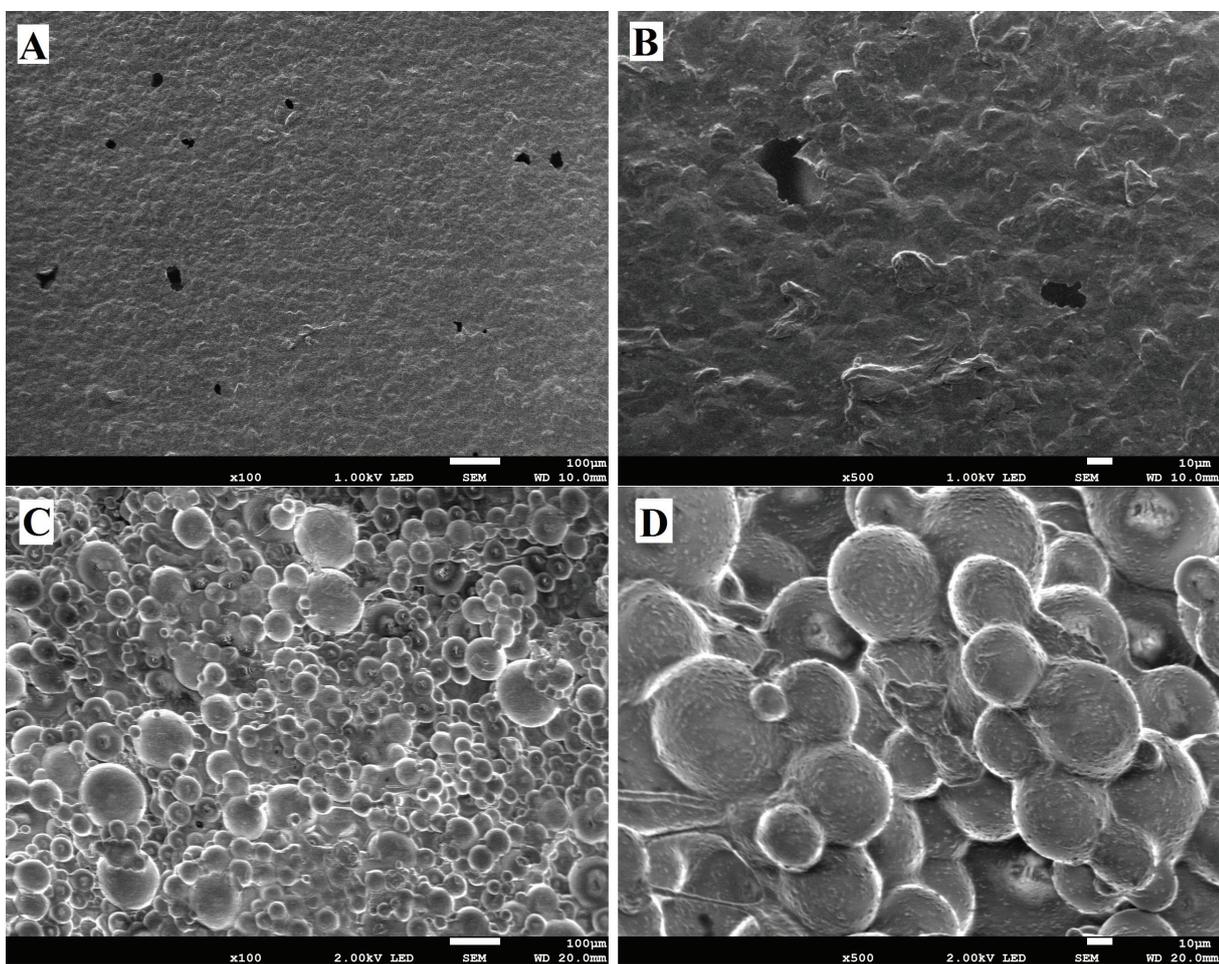
**Fig. 7.**  
Topography of the surface of bone cement before the corrosion test (high viscosity: 100x – A and 500x – B, low viscosity: 100x – C and 500x – D)

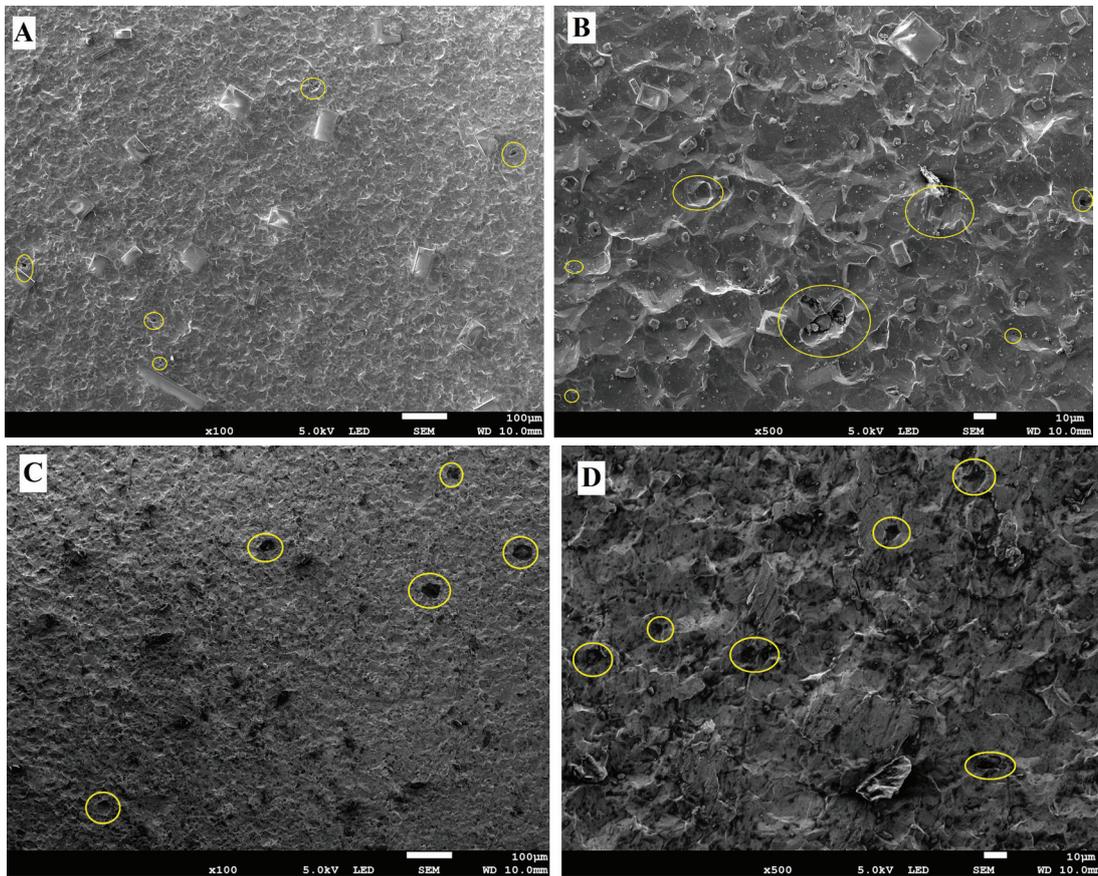
**Fig. 8.**

Topography of the surface of titanium after the corrosion test (Ringer's solution: 100x – A and 500x – B, Artificial Saliva solution: 100x – C and 500x – D, yellow circles – micropores/craters)

As a result of corrosion tests on the outer surface of material it can be notice a significant change in its structure (circles in Fig. 8-10). In the case of titanium, melt areas and numerous micropores or craters (Fig. 11) were observed and on bone cement general

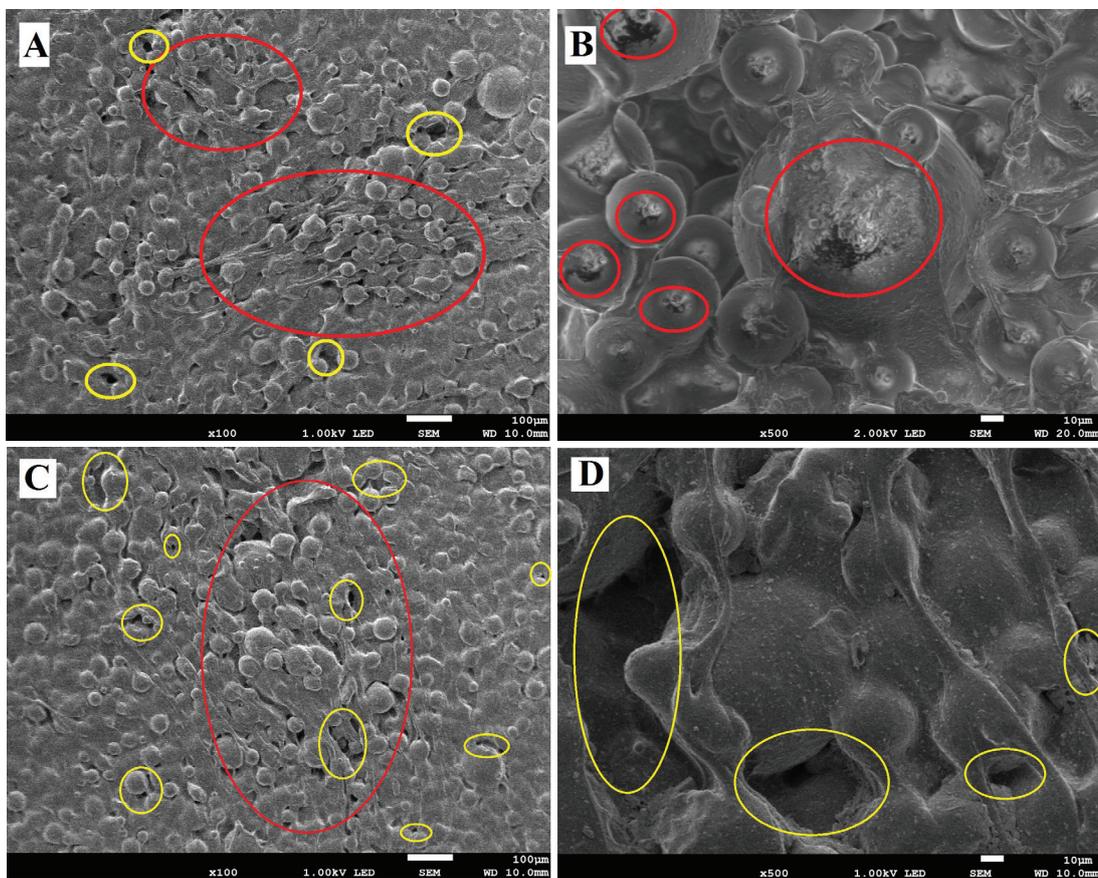
**Fig. 9.**

Topography of the surface of high viscosity bone cement after the corrosion test (Ringer's solution: 100x – A and 500x – B, Artificial Saliva solution: 100x – C and 500x – D, yellow circles – micropores/craters and red circles – areas of intense corrosion degradation)

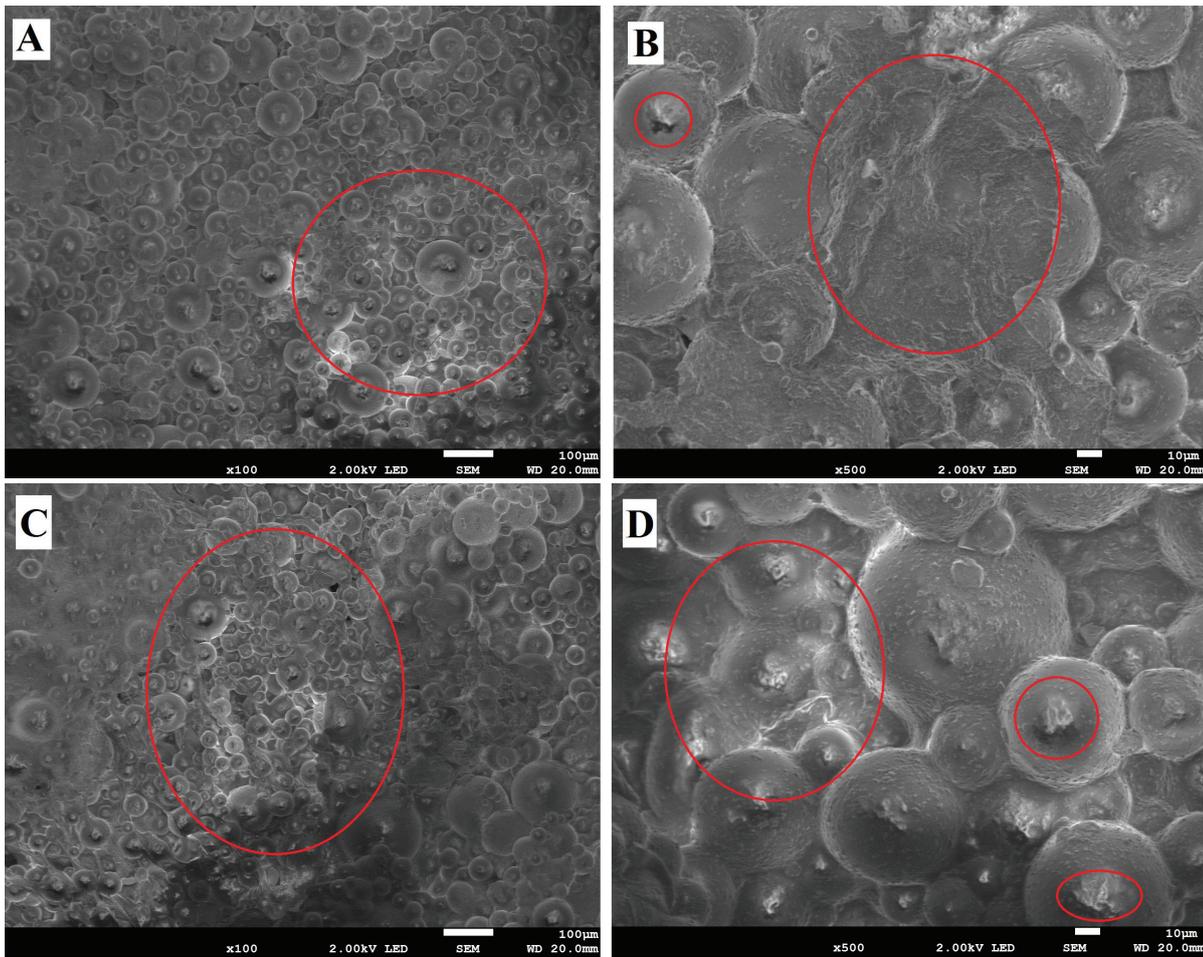
**Fig. 10.**

Topography of the surface of low viscosity bone cement after the corrosion test (Ringer's solution: 100x – A and 500x – B, Artificial Saliva solution: 100x – C and 500x – D, red circles – areas of intense corrosion degradation)

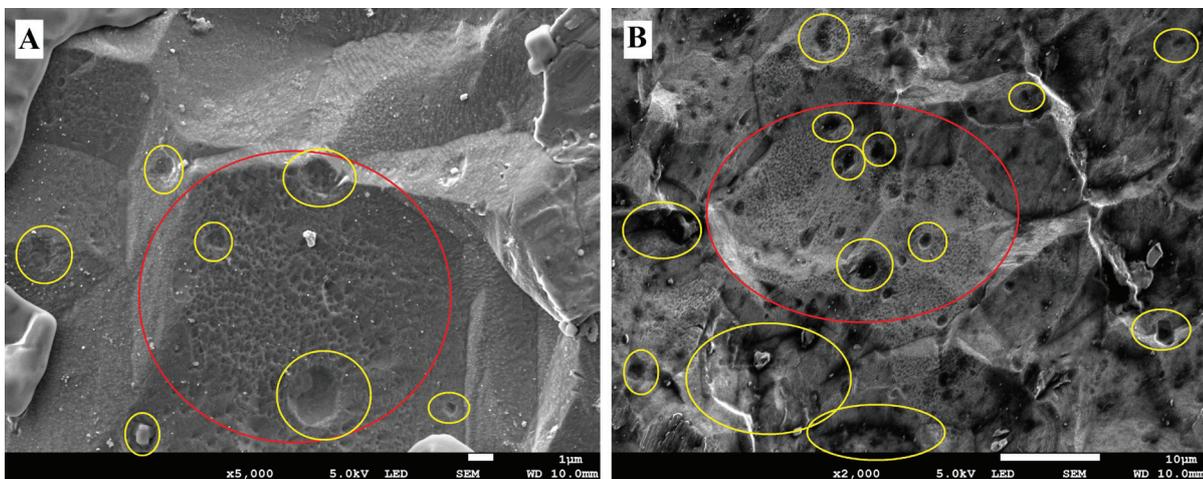
**Fig. 11.**

Corrosion changes on the surface of titanium specimens (Ringer's solution: 5000x – A, Artificial Saliva solution: 2000x – B, yellow circles – micropores/craters and red circles – areas of intense corrosion degradation)

surface etching and areas of intense corrosion degradation were observed (Fig. 12). It is suspected that the structure was dissolved/melted by the aggressive environment and corrosive currents.

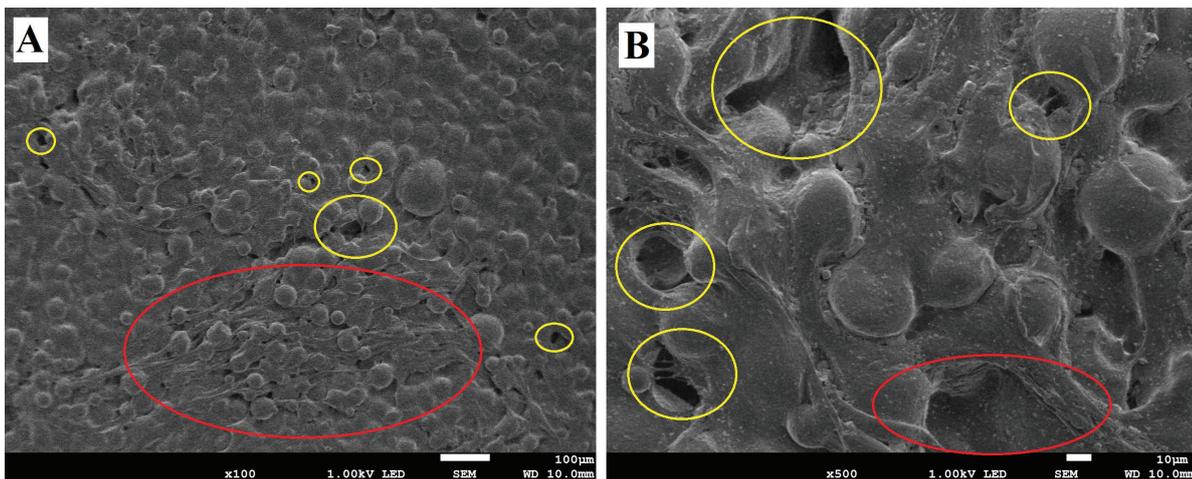
**Fig. 12.**

Corrosion changes on the surface of bone cement coating (Ringer's solution and high viscosity bone cement: 100x – A, Artificial Saliva solution and low viscosity bone cement: 500x – B, yellow circles – micro-pores/craters and red circles – areas of intense corrosion degradation)
